# WATERPROOFING & MASONRY RESTORATION PROJECT PROFILE

## BOSTONVIEW APARTMENTS, BEACON HILL — BOSTON, MA

*Elaborate reconstruction of an 18 story apartment building on an extremely tight site in the historic Beacon Hill area of Boston. The project included total reconstruction of building's parapets and extensive brick veneer exterior reconstruction in contiguous areas.*

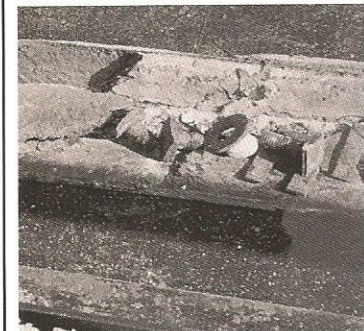
*This 1960's building had extensive water infiltration problems stemming from faulty parapet construction, and the project required extensive troubleshooting of the brick veneer exterior façade to determine the source of the water problems.*

*Water trapped beneath brick veneer corroded steel angles*

At the upper level construction area, Metropolitan dismantled the brick veneer wall from the 18th floor shelf angle to the 17th floor shelf angles. Structural steel relieving angles on both the 17th and 18th floor were replaced. (over)

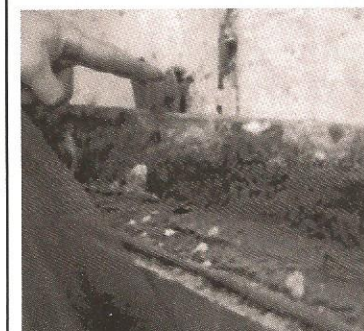
*Corroded anchors failing at structural relieving angles*

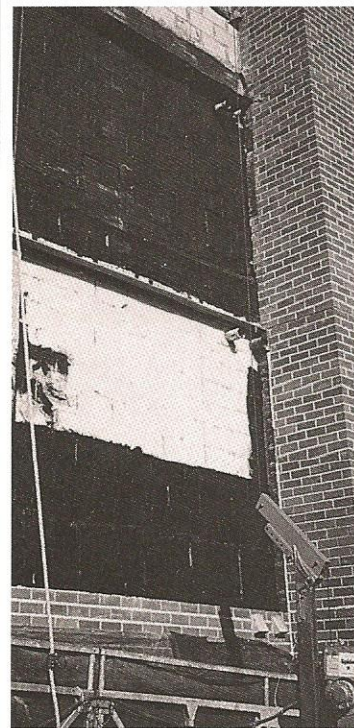
*Damage within building façade required new waterproofing systems*

The project required the installation of a new EPDM waterproofing membrane in the cavity wall from the 17th floor shelf angle over the spandrel beam. This system tied into the existing 18th floor vapor barrier and the existing roof membrane. Brick veneer was rebuilt on the 17th floor.

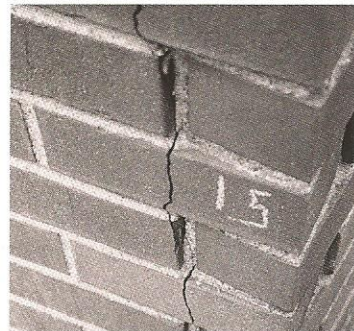
*1/2" crack in brick veneer required repair*

A 1/2 inch exterior crack on this side of the building extending from the 13th floor to the 1st floor required the installation of Dur-A-Wall Spiral Anchors to the brick veneer and spandrel beams. The crack restoration was finished by the utilization of a soft movable joint sealant.

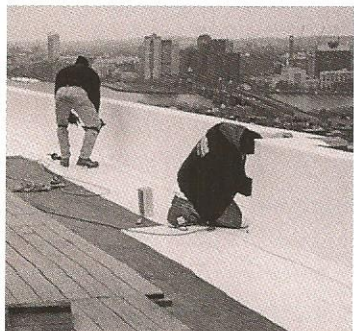
*New parapet waterproofing systems tied to roof EPDM membrane*

Strict construction parameters were met to ensure watertight construction in the parapet areas. As the parapet wall was being constructed, a new flashing membrane was simultaneously being installed on the parapet and tied into the existing roof. Thus, the building was kept watertight throughout the entire demolition and construction process. The waterproofing of the parapet areas also included the installation of a metal coping to the leading edge of the parapets.
